NBSIR 74-425

Investigation of G-74 Currency Plate Tensile Properties and Performance

Test Report

Prepared for
Electrolytic Section
Bureau of Engraving and Printing
Department of the Treasury
Washington, D. C. 20226

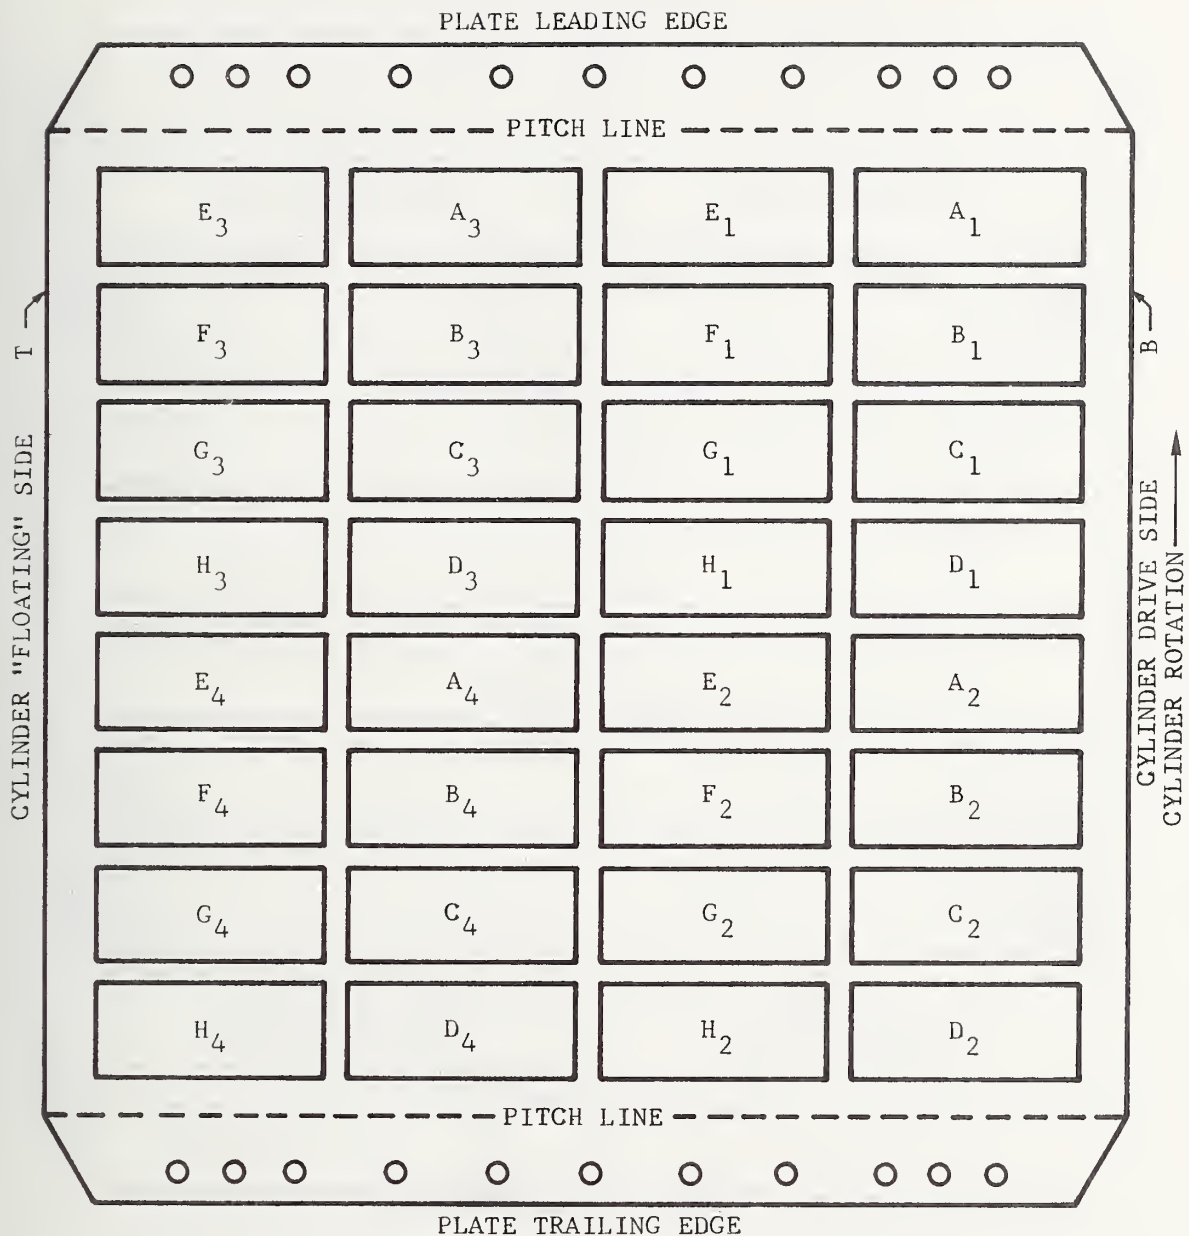
Figure 1. Sketch Showing Individual Note Locations on a Currency Plate, Plate Alignment on a Printing Press and Original Positions of Plate Bottom (B) and Top (T) in Electroforming Tank.

Figure 1 is a sketch showing individual note locations and the leading and trailing edges of a currency plate with respect to the positions of these edges on a printing cylinder and the direction of cylinder rotation. Note that T and B, representing the original top and bottom positions of a plate in the electroforming tank, are located at angles of 90 degrees counterclockwise to the leading edge and trailing edge, respectively.

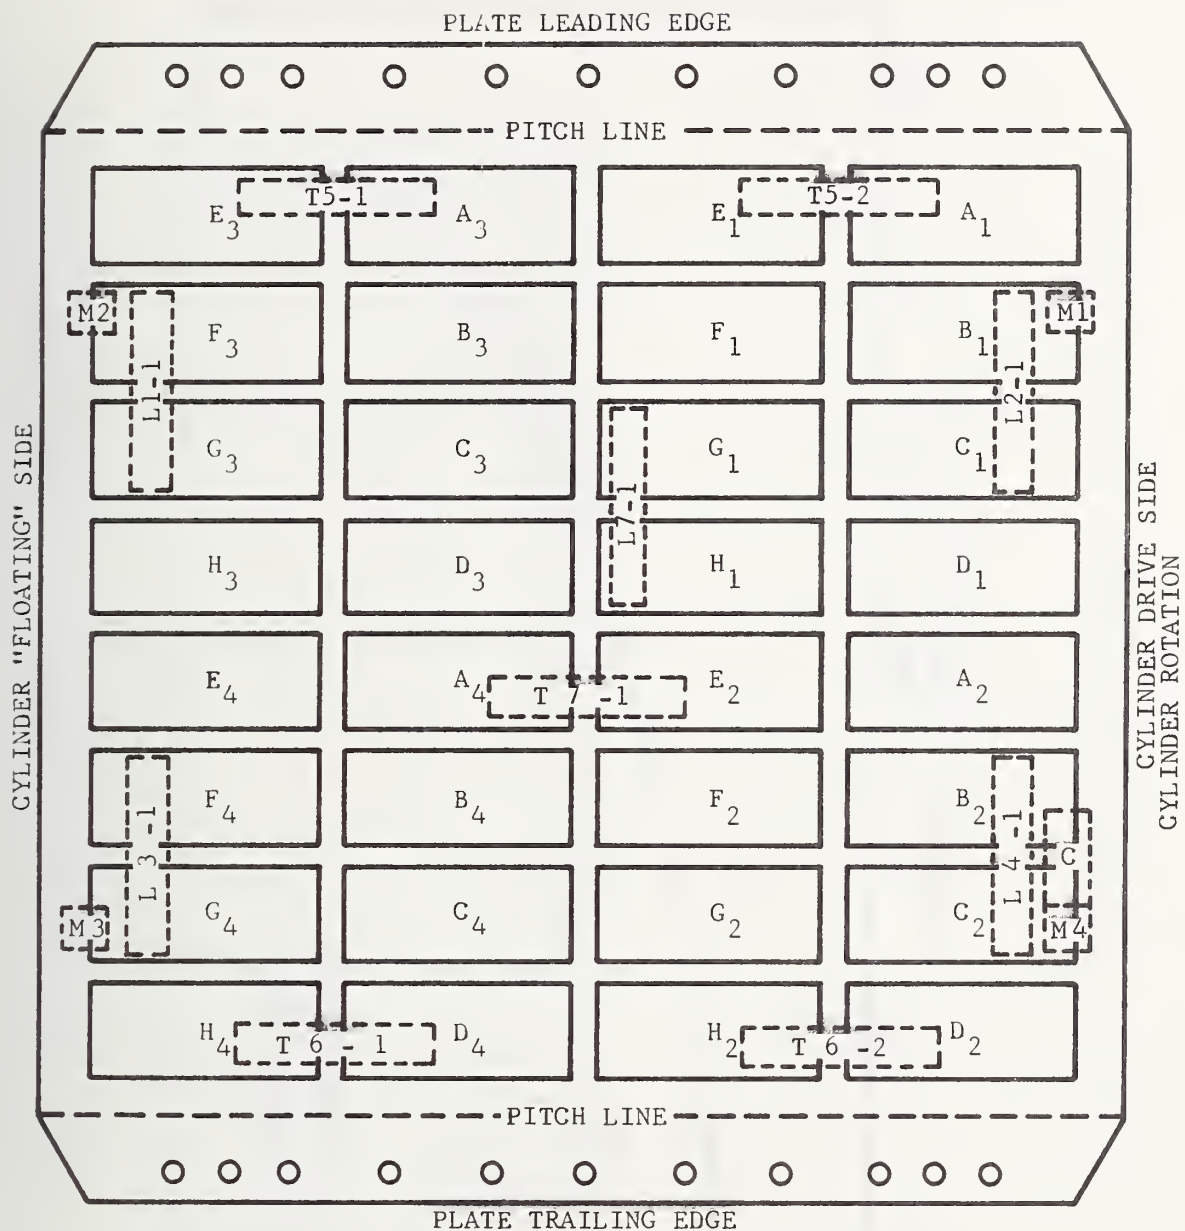
Figure 2. Cutting Map Showing Location of Tensile, Metallographic and Chemical Analysis Specimens Cut from Blank Plates, 1C and 2C. Not drawn to scale.

L - Longitudinal tensile specimen.
 T - Transverse tensile specimen.
 M - Metallographic specimen.
 C - Chemical analysis specimen.

The tensile properties of blank plates 1c and 2c were obtained from ten specimens cut from each plate. The identifications and locations of these specimens are given in Figure 2. The letters L and T in the specimen identifications indicate that the specimens were cut from these blank plates so that their long axes would be aligned parallel or transverse to the direction of plate rotation, respectively, had these plates been regular basso printing plates. Face and back plate tensile properties were attainable by NBS only from specimens cut from the face and back plate strips submitted. These tensile specimens necessarily were cut so that their long axes were transverse to the direction of cylinder rotation. Tensile test specimens were machined using the as-received thickness (approx. 0.030 inch), and a 0.500 inch width and 2 inch gage length in the reduced section. They were tested in accordance with ASTM Designation E8-66.

Chemical analyses by spectrometric or combustion methods were performed on samples cut from the areas of blank plates, 1c and 2c, shown in Figure 2, and from strips from plate Numbers 42233B and 42248B.

Specimens were cut from the areas of plates 1c and 2c, shown in Figure 2, for metallographic examination. Metallographic examinations were conducted on specimens cut from strips of face plates numbered 42233, 42239, 42245 and 42248 and from strips of back plates numbered 7637, 7639, 7645 and 7646.

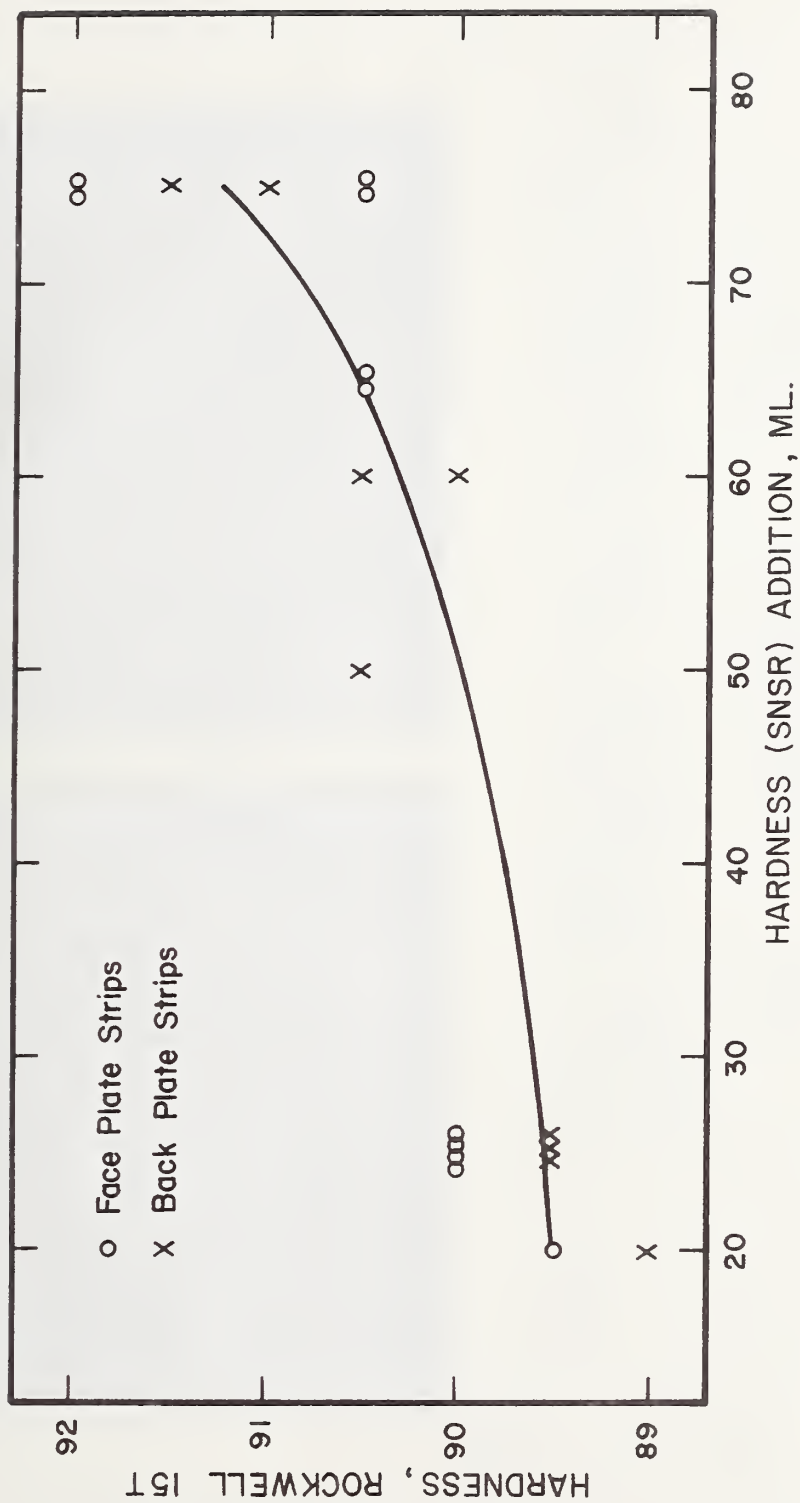
Figure 3. Effect of SNSR Addition in Electroforming on Hardness of Strips.

Figure 3 shows, graphically, the effects of the hardener addition on the hardness of strips from face and back plates. There is an apparent exponential increase in hardness with increase in the hardener addition. However, paucity of data points and scatter in the available data are great and therefore preclude the derivation of a reliable curve which would indicate the amount of hardener addition needed to achieve a given hardness.

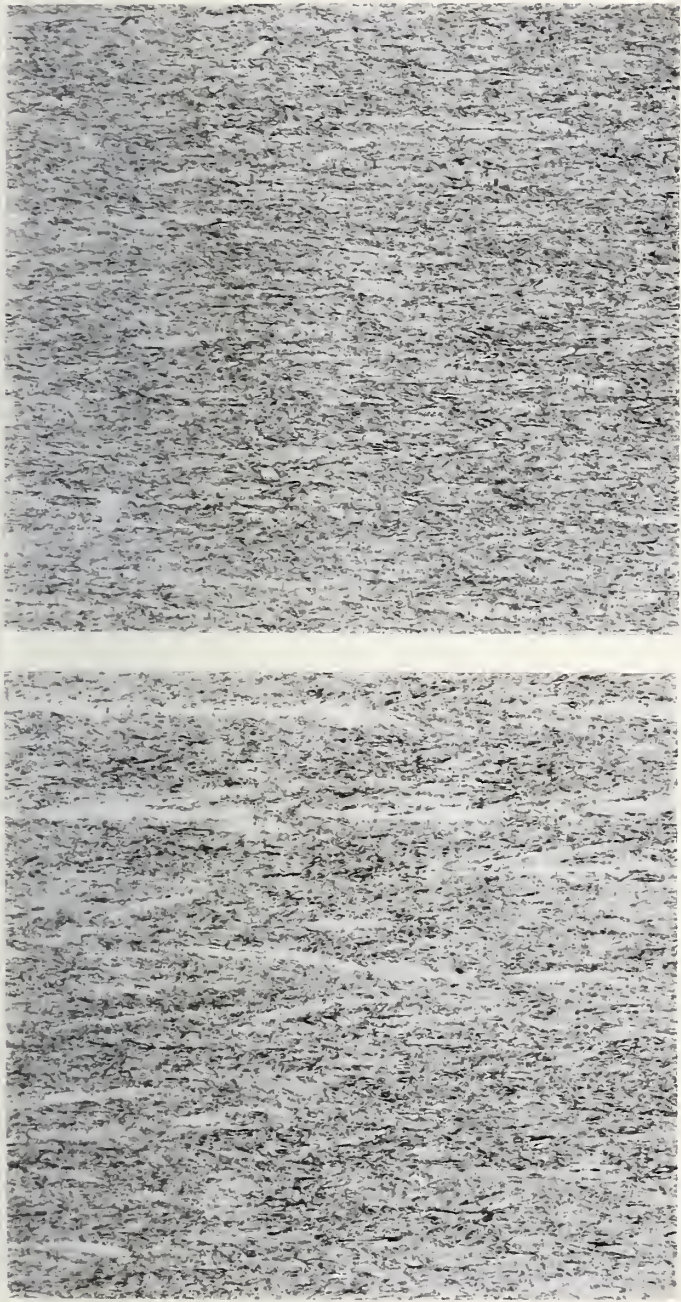
Figure 4. Photomicrographs Showing Structures in Blank Plates, 1c and 2c. The structures shown are representative of that in plate cross-sections. Etched with Carapella's reagent following a 3 acetic to 1 nitric acid chemical polish.
X 250

Plate No.	Specimen Location (See Figure 2)	SNSR Addition	
			ML	
a	1c	M1		25
b	2c	M3		50

Blank plate microstructures are shown in Figure 4 and face and back plate microstructures in Figure 5. The columnar grains in each view are normal for electroformed nickel. A 50 ml SNSR addition in the electroforming process produced a finer grain size than did a 25 ml addition, as shown in Figure 4. Similarly, 75 ml additions produced finer grain sizes than 20 or 25 ml additions, as shown in Figure 5. Microscopic examination of face and back plate strip specimens revealed no structural discontinuities that could affect the mileages of the plates from which they were cut.

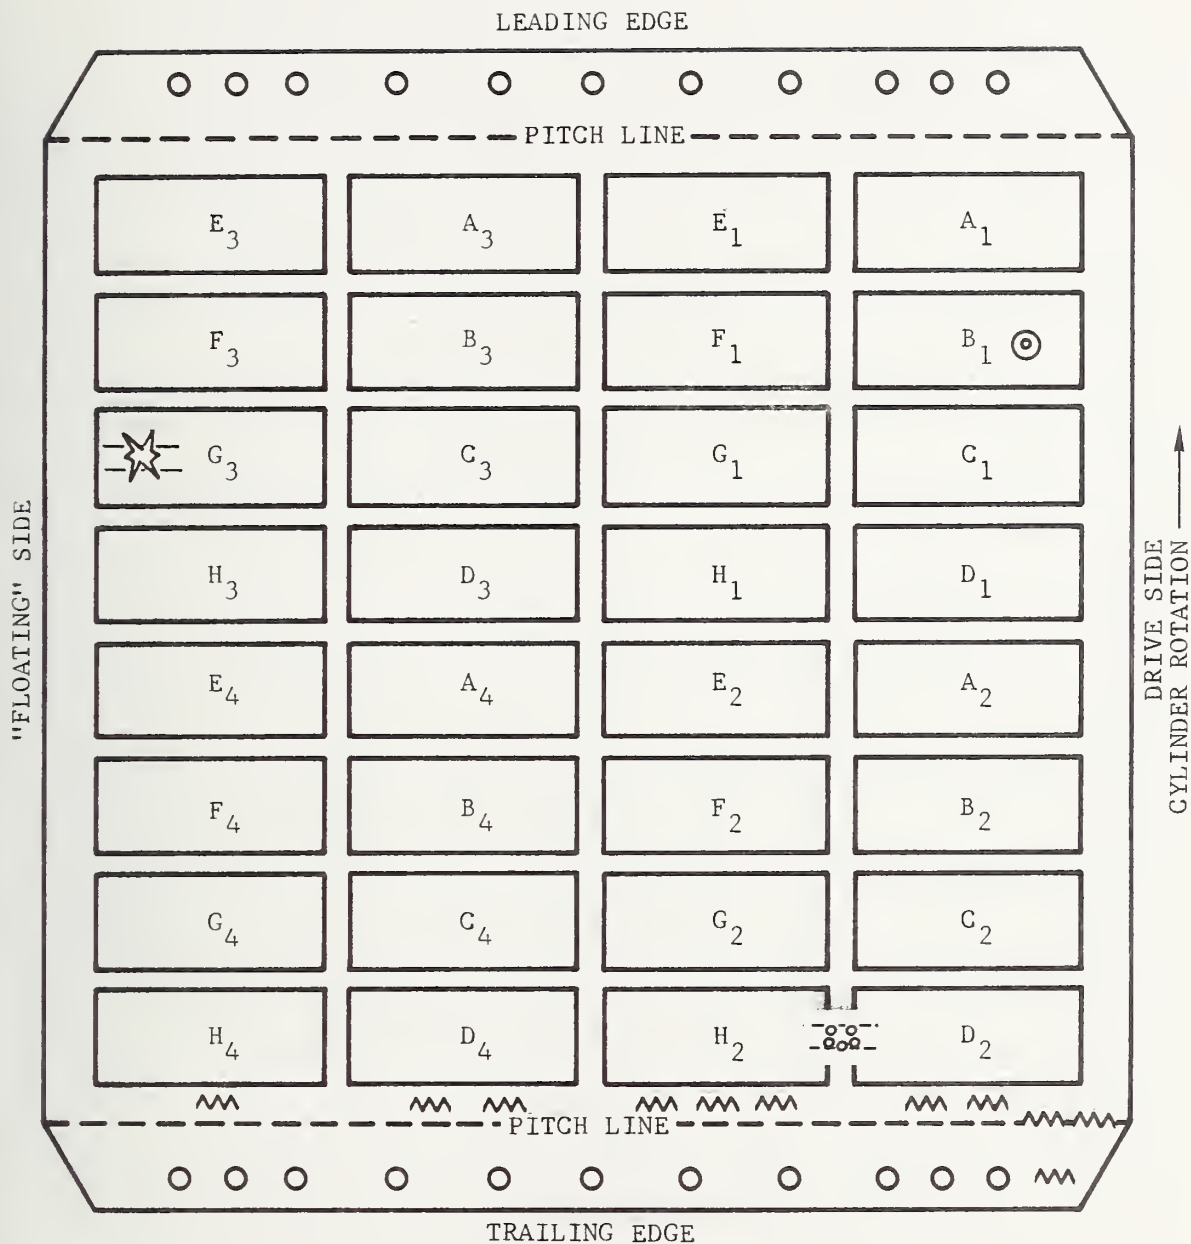
Fatigue cracking was the chief cause of face plate failure. Fatigue cracking occurred between the bottom margins of the H₂, D₂, H₄ and D₄ notes and the trailing edges of these plates and also along the trailing edge pitch line of these plates. There was only one instance, each, of a dimple, of rippling and blistering, and of a ball-up (rippling) failure. Face plate failures were largely concentrated adjacent to the H₂ and D₂ notes.

Figure 6. Sketch Showing Nature and Approximate Location of Face Plate Failures.

Symbols indicate each failure of a similar nature.

~~~~~ - Fatigue cracking.

⊘ - Rippling and blistering

⊛ - Ball-up (rippling)

Figures 6 and 7 are sketches intended to indicate the nature and approximate location of failures of face and back plates, respectfully. This information has been obtained from pertinent record sheets submitted by Bu E&P.

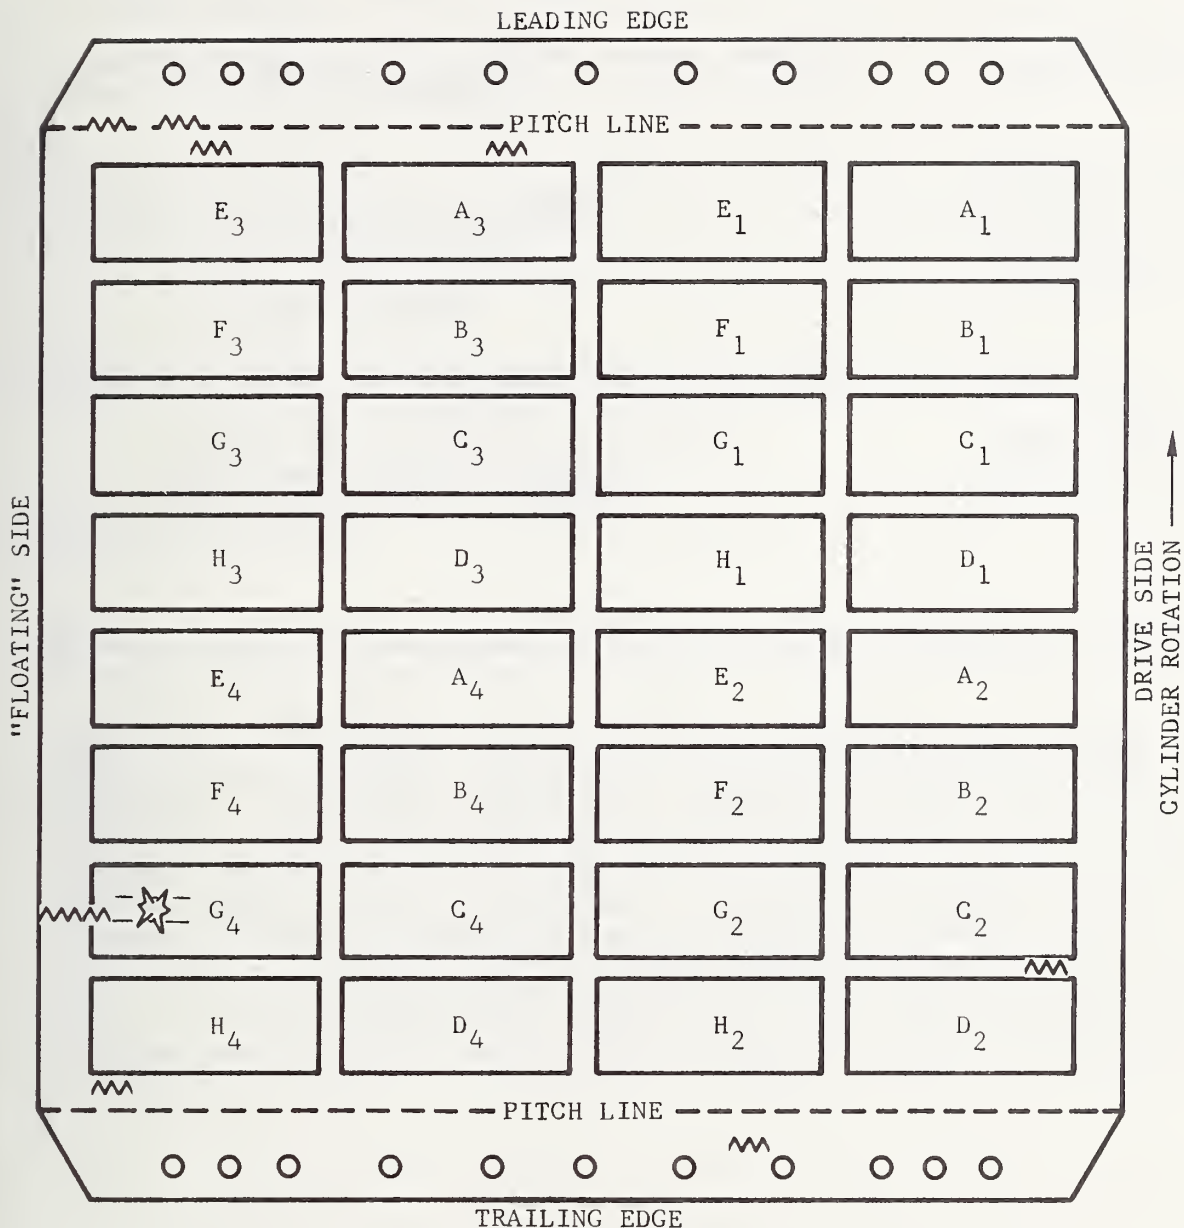
Fatigue cracking was also the chief cause of back plate failure. Fatigue cracks occurred along the leading edge pitch line adjacent to the E₃-A₃ notes and between the top margins of the E₃ and A₃ notes and the leading edge pitch line of the back plates. Fatigue cracking also occurred adjacent to the G₄, H₄ and C₂ notes and adjacent to the trailing edge pitch line, as shown in Figure 4. There were three instances of back plate ball-up and rippling failure.

Figure 7. Sketch Showing Nature and Approximate Location of Back Plate Failures.

Symbols indicate each failure of a similar nature.

~~~~~ - Fatigue cracking.

—★— - Ball-up and rippling. (One Shown; Approximate location of two additional failures of this nature were not reported.)
